Intel® Pentium® III Processor Specification Update

Release Date: December 2000

Order Number: 244453-024

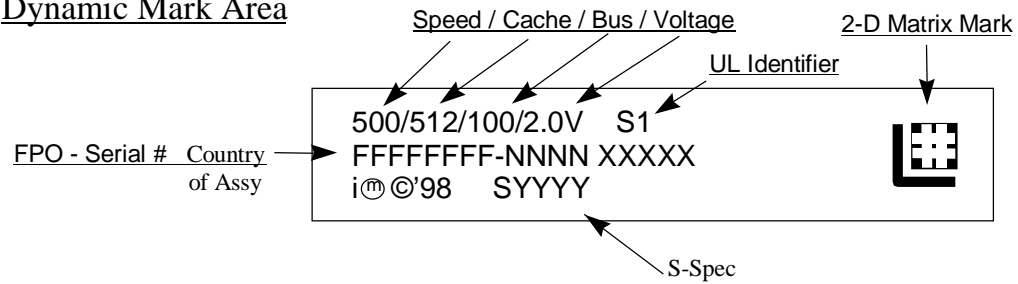
Pentium® III Processor and Boxed Pentium® III Processor 3 Line Markings

Dynamic Mark Area

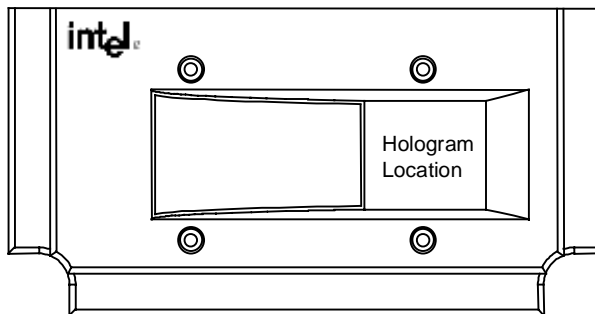
Pentium® III Processor Markings
